1. REPORT DATE (DD-MM-YYYY) 29 Apr 2005		2. REPORT TYPE Consultative Letter		3. DATES COVERED (From – To) 1-2 March 2005	
4. TITLE AND SUBTITLE Evaluation of Laser De-Painting System				5a. CONTRACT NUMBER	
				5b. GRANT NUMBER	
				5c. PROGRAM ELEMENT NUMBER

SUBJECT: Consultative Letter, IOH-RS-BR-CL-2005-0044, Evaluation of Laser De-Painting System

b. *Laboratory Study:* For this assessment, AFIOH was asked to look at a laser de-painting system that is being considered for field use. This assessment took place in a laboratory setting; however, all removed coatings were standard aircraft primers and paints from the AF supply system. The coatings were applied to two-foot square aluminum or composite test panels and these panels were painted under the same technical requirements established for aircraft painting.

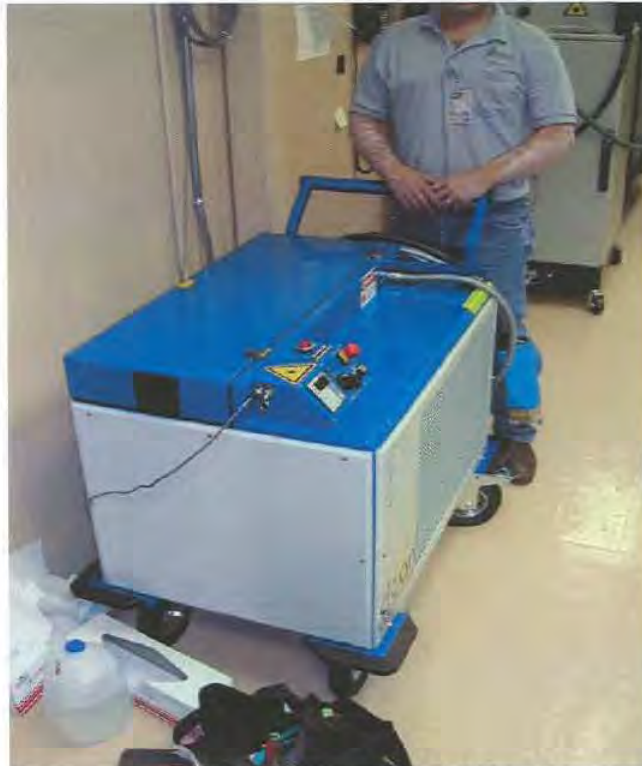
c. *Cleanlaser.* The Cleanlaser optical machining system was developed for use in industrial cleaning processes. The Cleanlaser 120 Q is an ANSI Class IV laser operating at 120 W average power at a nominal wavelength of 1,064 nm. The laser and laser system chiller are mounted on a cart for mobile operation (Figure 1). The laser beam is delivered via fiber optical cables and a manually operated laser head. The laser system was used with a Fumex FA2 HEPA filtration unit, which removes de-painting products at the laser head. Paint is removed from the substrate via laser ablation.

Figure 1. Cleanlaser 120 Q System

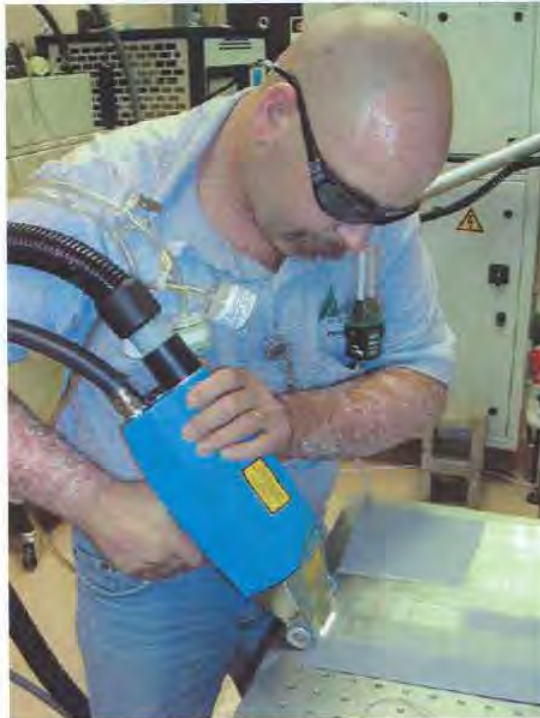
e. *Removal Process.* During de-painting tasks, the operator is required to place the laser head above the substrate surface and move the head over all areas where paint removal is required (Figure 3). Additional pictures of the process are shown in attachment 1. Repeated passes might be necessary to ensure complete coating removal. The laser head had rollers on it that allowed the operator to easily maneuver the laser head around the square test panels. The laser was turned on and off with a simple trigger system and the laboratory was equipped with interlocks on both entry doors.

Figure 3. De-painting a test plate

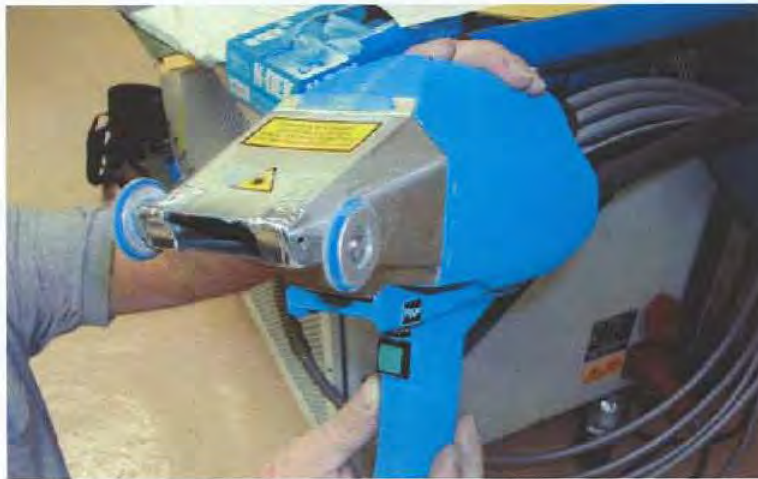
f. *Ventilation System.* A Fumex F-2 portable ventilation system was incorporated into the laser head. The Fumex system connects directly to the laser head and has a HEPA collection bag. After particles are removed within the collection bag, the exhaust air is sent to the building's industrial ventilation system, which eventually sends the air to a stack. The capture port was located directly behind the laser and the system was designed to capture the removed coating particles. Figures 4 and 5, below, depict how the ventilation system is incorporated into the laser head.

Figure 4. Laser head with operational nozzle

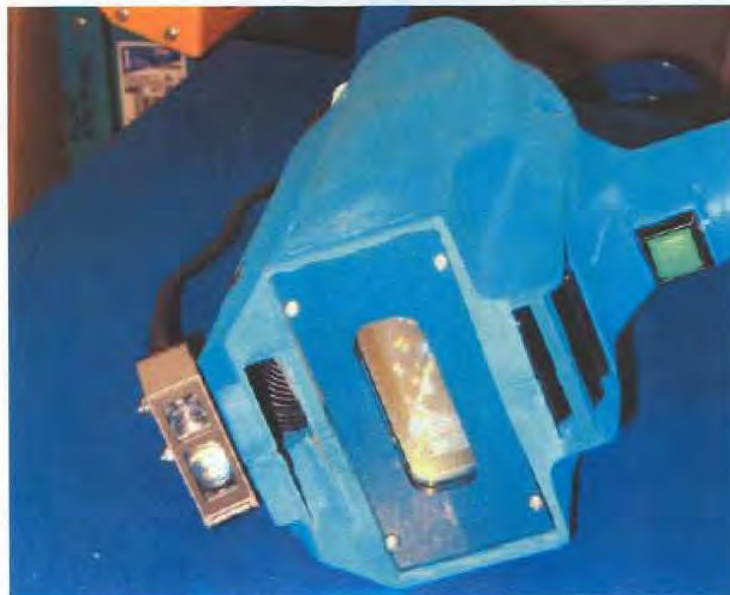
Figure 5. Laser head with nozzle removed. (Not operational configuration)

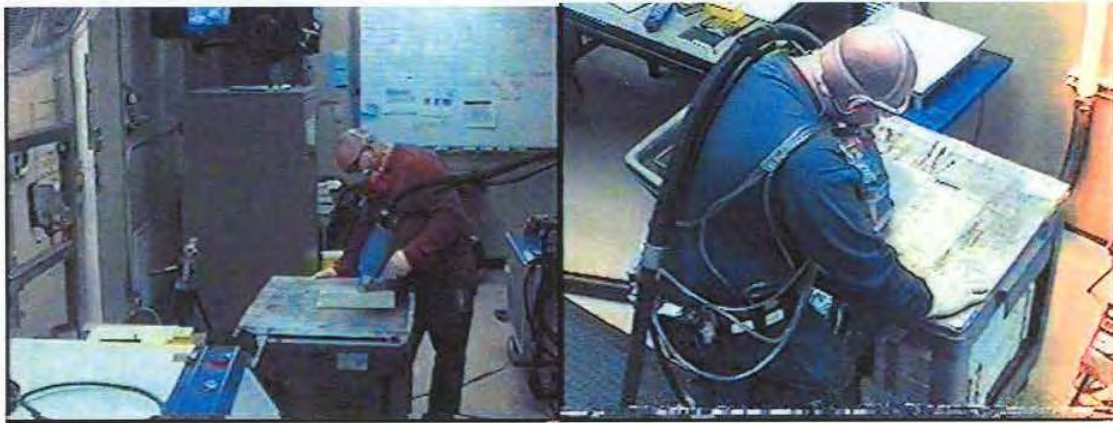
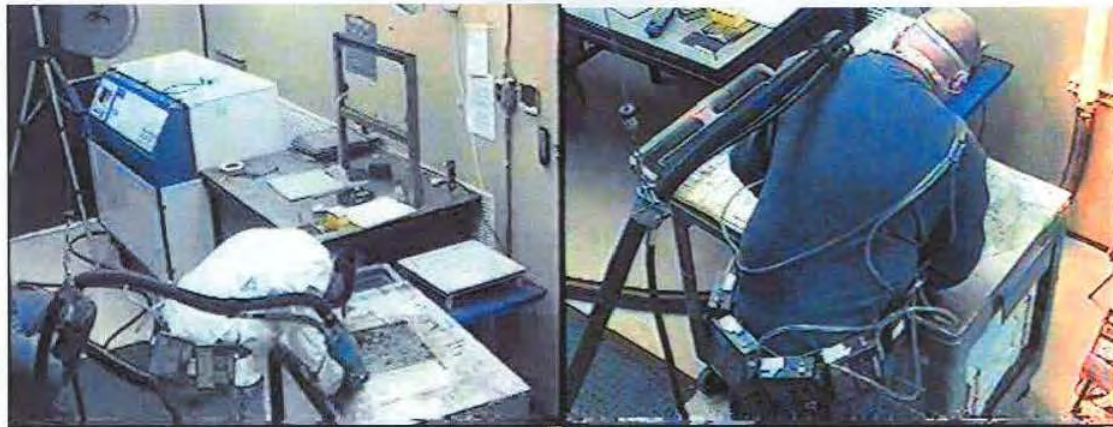
Atch 1

Pictures of the Laser Stripping
